## ACE Preferred Inspections, Inc.

PO Box 1154 Mt. Pleasant, SC 29465

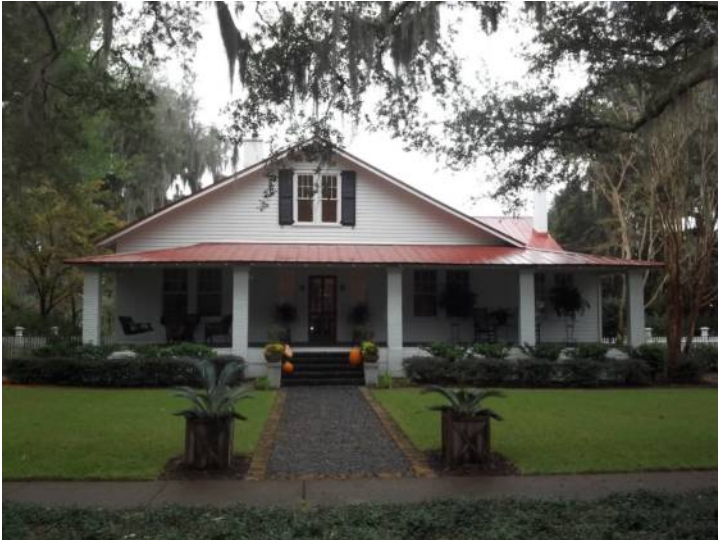
Squeeze connector absent where conductors enter bottom of service panel. Recommend an electrician install one.

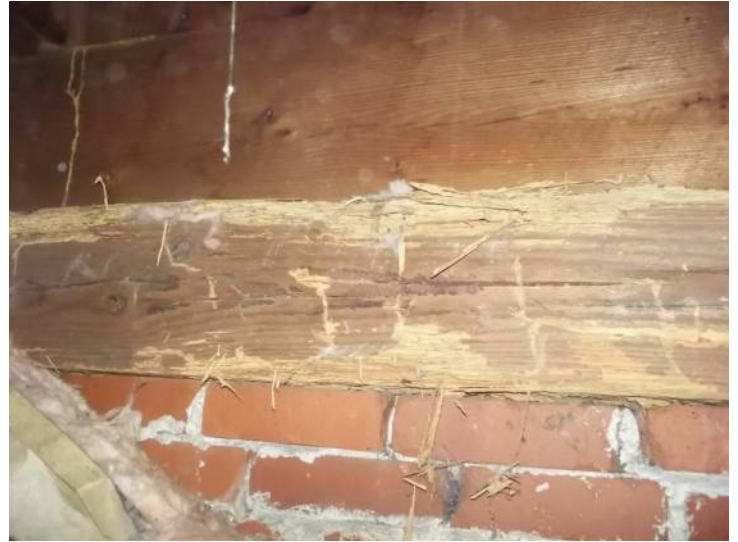
Banding along left side of original structure are insect and moisture damaged.

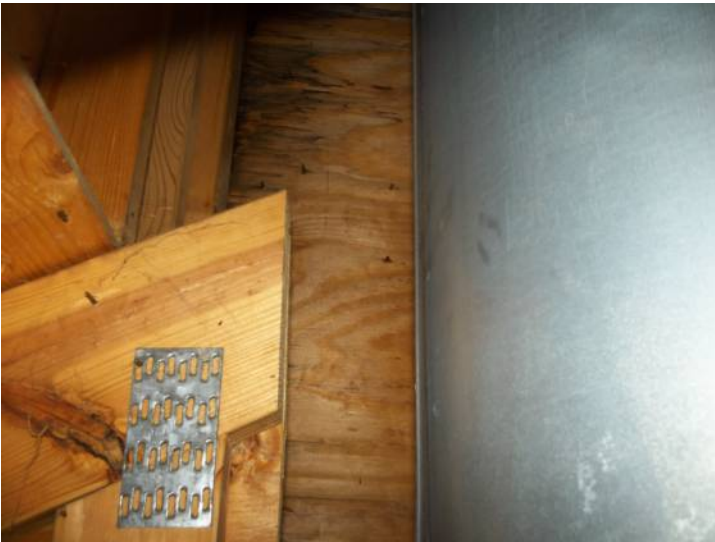
Truss member has been cut to accommodate living room fireplace flue, stains present in chimney chase at wall sheathing.

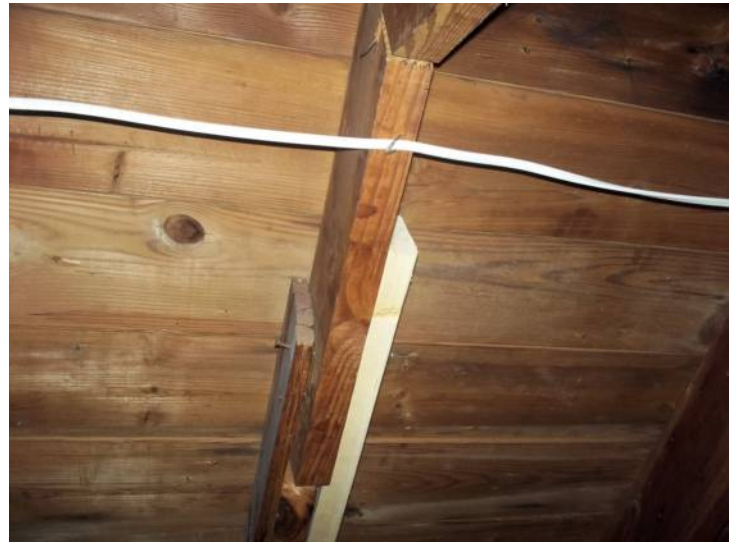
Rafter splices present above middle hall and at right front are not properly reinforced.

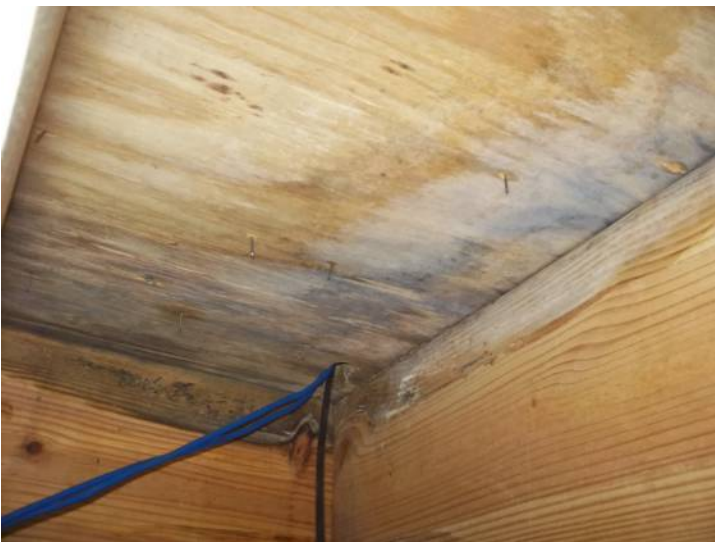
Water stains are present on sub-floor in rear crawlspace at left front corner of living room by side entry door.

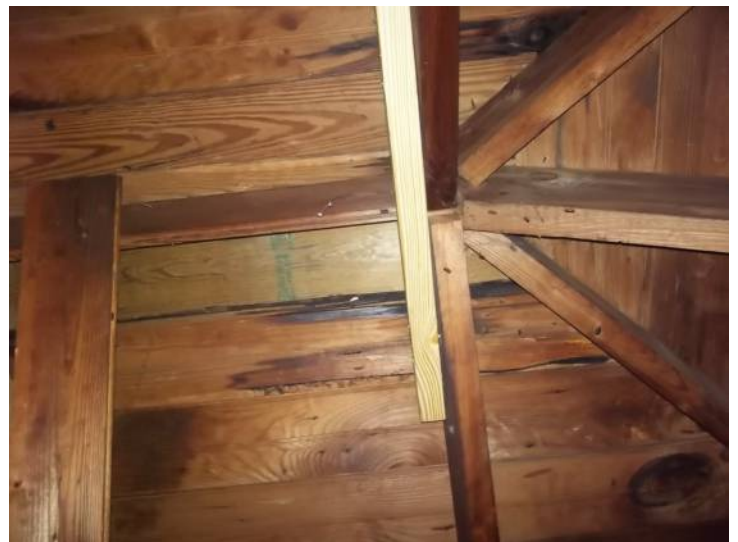
Stains present at middle hip ridge. Hip ridge is not supported.

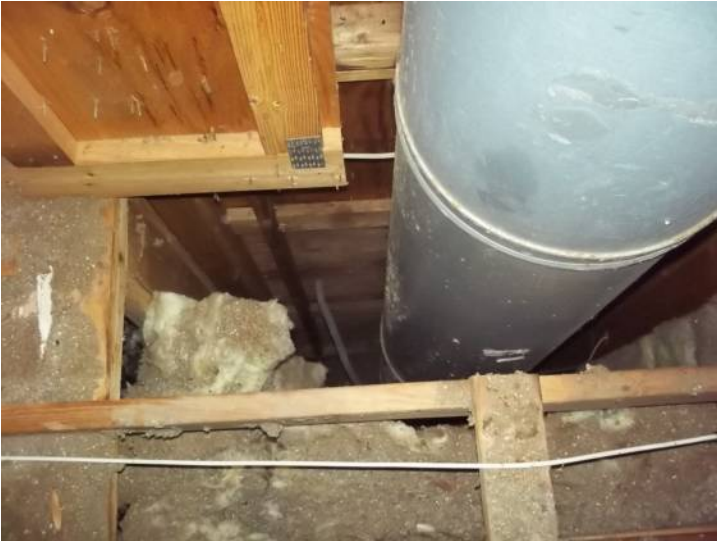
Chimney chase is open to the attic, truss has been cut.

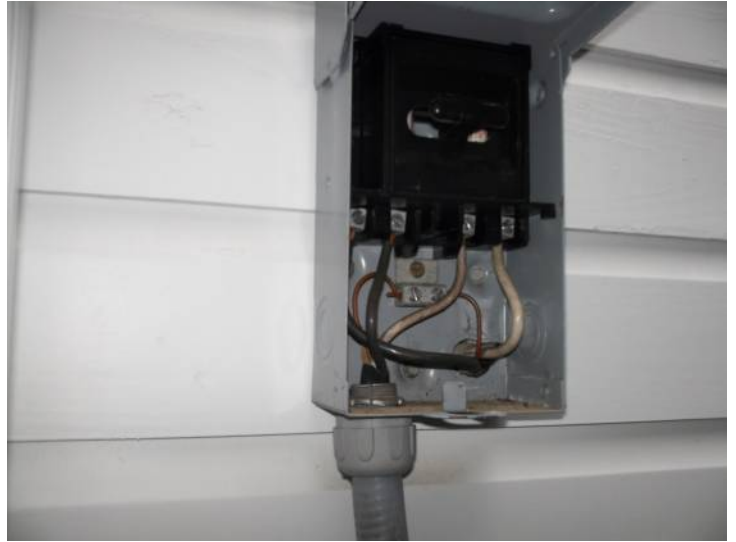
Furnace disconnect inner cover is missing at right side of structure.

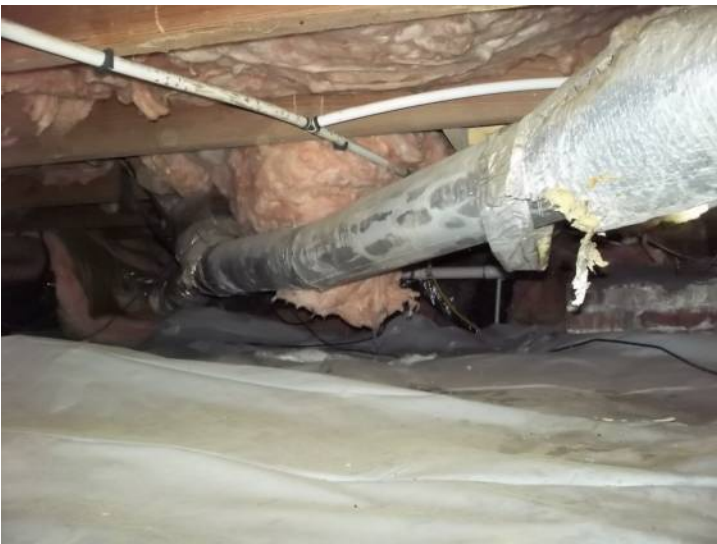
Crawl space ductwork insulation is absent under rear hall at original structure.

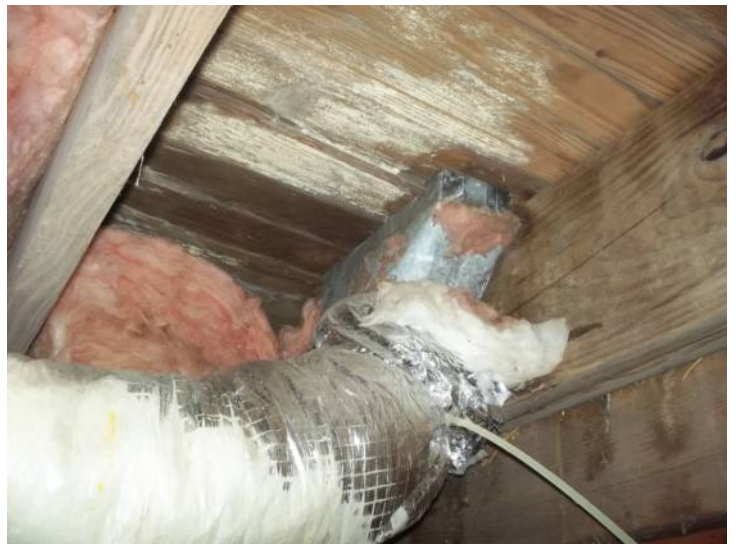
Stains and deteriorated sub flooring are present around floor registers where duct connection is partially detached.

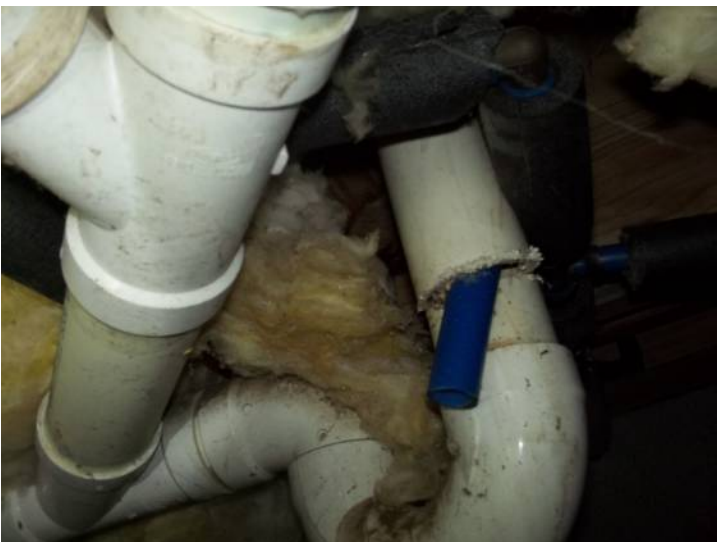
Drain pipe under master shower has been severed.

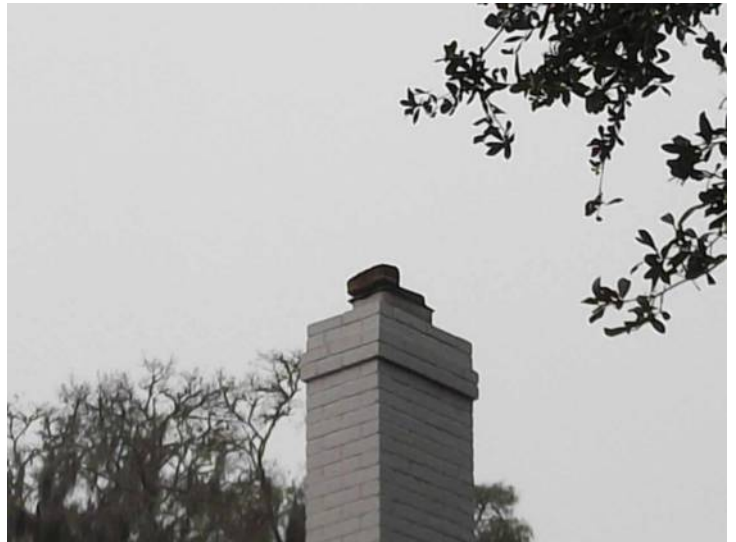
Right chimney flue cover is held in place by a brick, flue is blocked and currently unsafe to use.

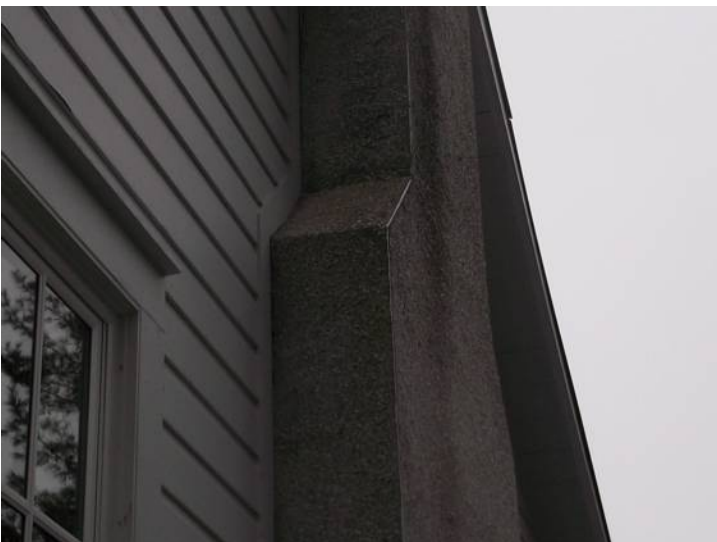
Living room chimney shoulders are stucco.

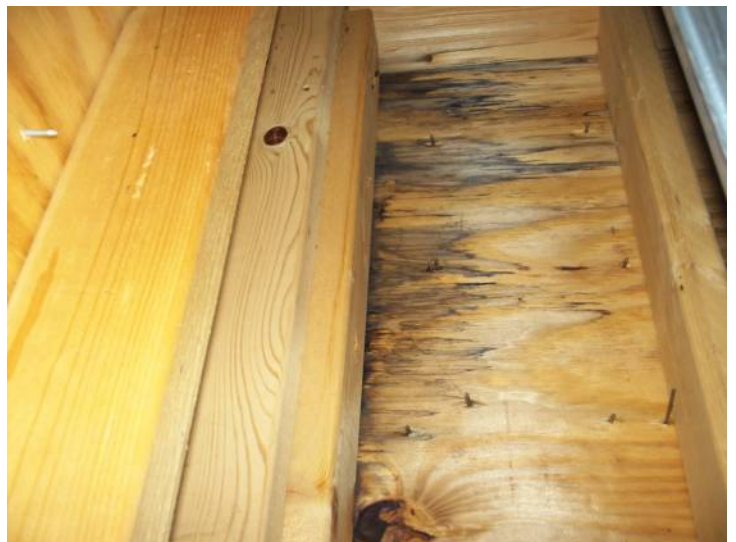
Living room chimney stucco exterior has stains present in chase at top by cover.

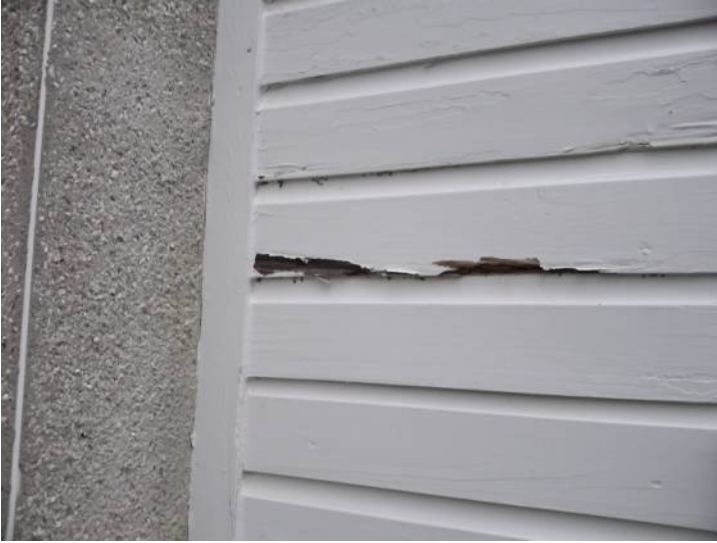
Rotted wood observed at siding at front of left rear chimney, caulk filled backer rod expansion joint absent chimney and siding.

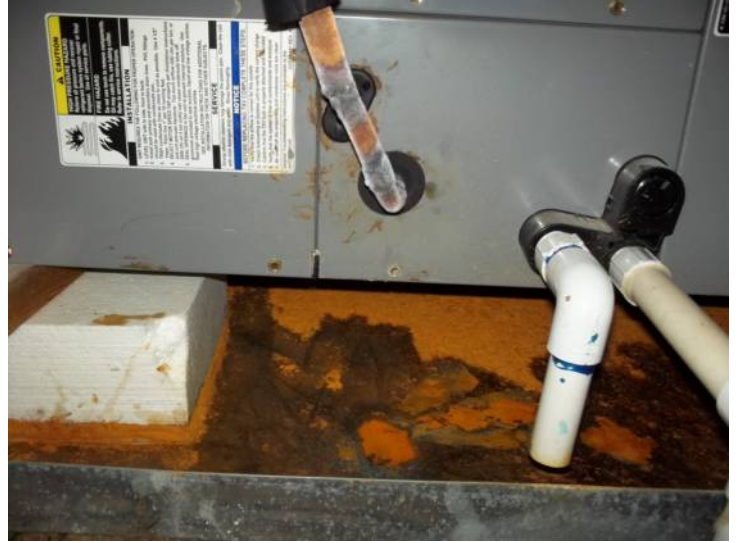
Rust stains are visible in guest air handler pan, refrigerant line insulation is short at unit casing.
